## **E15 error code**

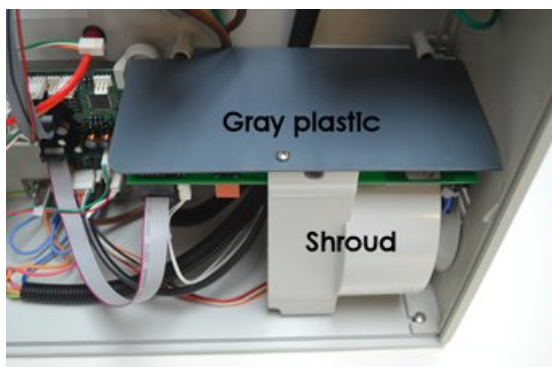
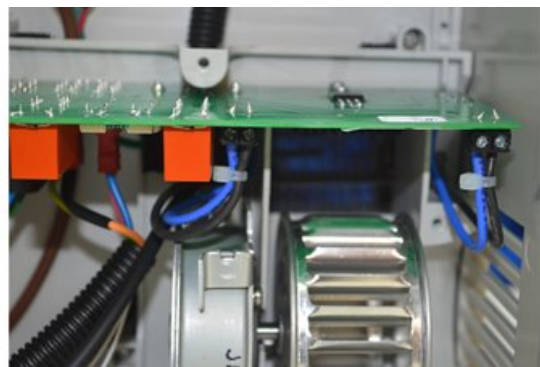
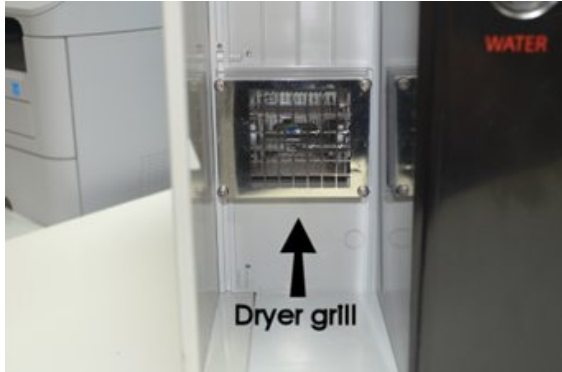
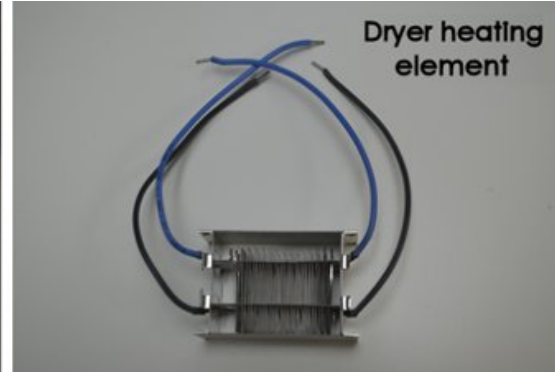
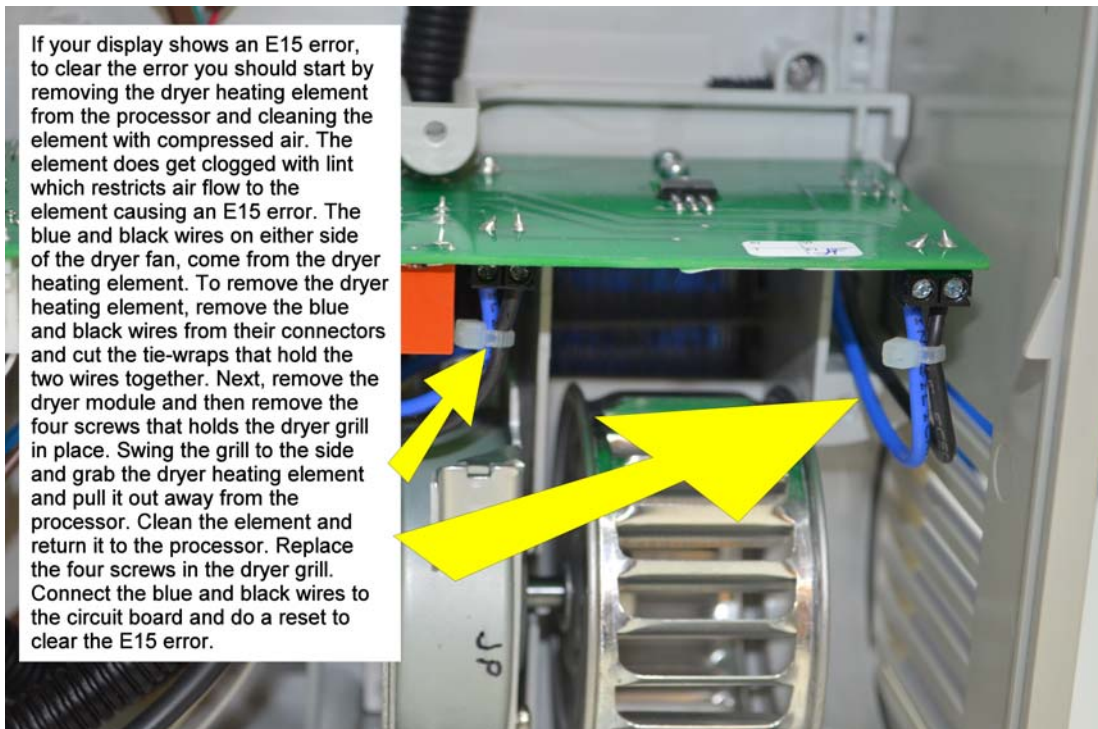
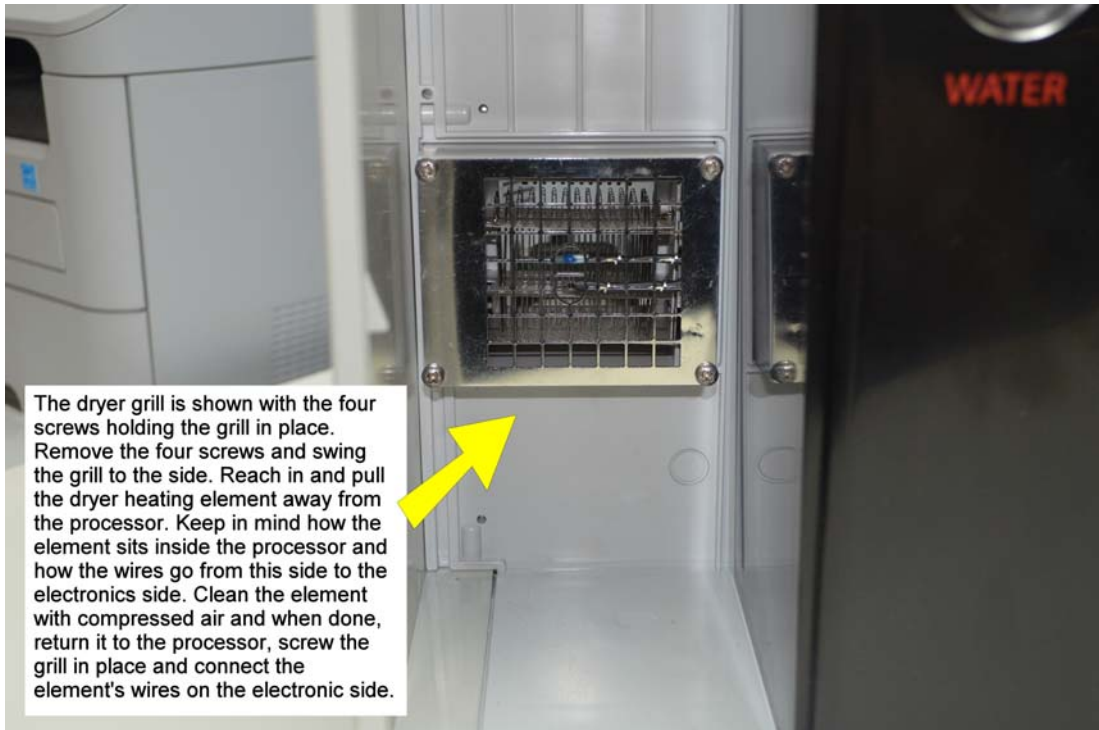
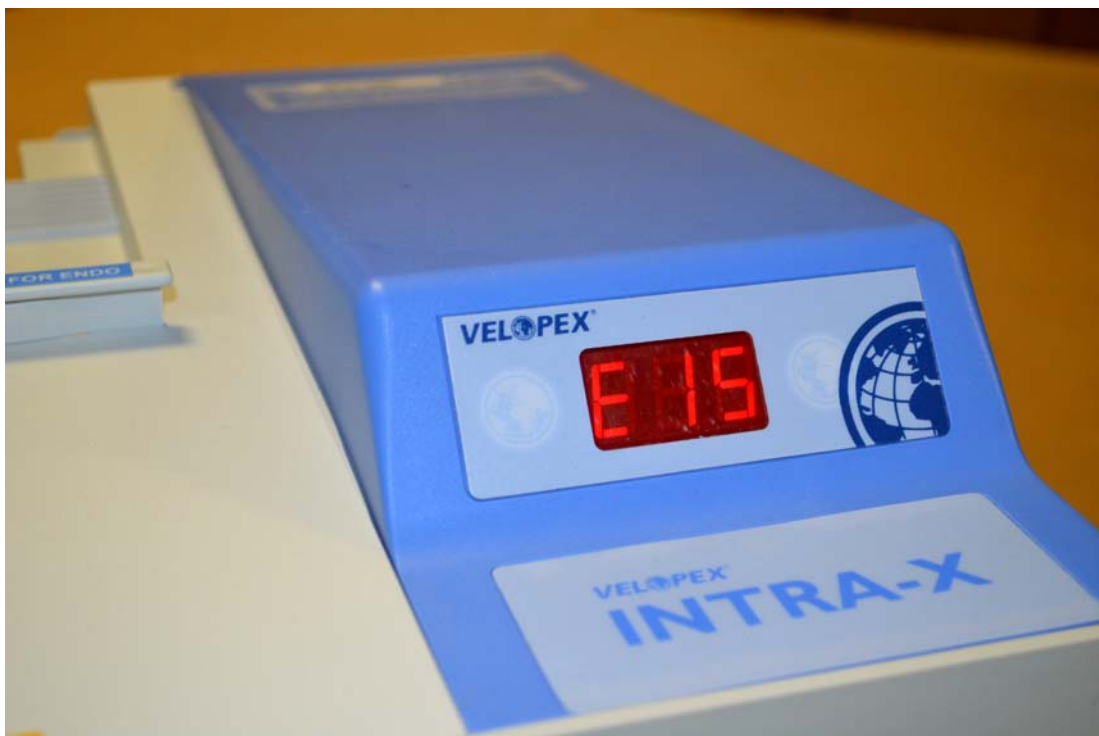
To clean the dryer heating element correctly, it must be removed from the processor. We will be addressing the MK6 processor's cleaning procedures. The MK5 is basically the same. The only difference is where the electronics sit in an MK5. Refer to the photos below to help you identify and locate components mentioned below.

Once the side panel is removed locate the plastic shroud that covers the dryer fan. Remove the gray piece of plastic that sits on top the shroud. One screw and some Velcro hold it in place. Next remove the four screws that hold the shroud in place. One screw is located on the bottom left of the shroud, one screw is located on the top of the shroud and the final two screws are located on the right side of the shroud. Remove the shroud.

The circuit board that sits upside down above the dryer fan is the AC Power Circuit Board. You will see two sets of black and blue wires in the middle and right side of the circuit board. Remove these wires from their connectors. You will need to cut the tiewraps that goes around the wires. Replace the blue lid back in place. Don't screw it in place at thie time.

Now go to the other side of the processor. Remove the white lid that covers the tanks and modules. Remove the dryer module and the side panel. Look in the area the dryer module sat. You will see the dryer grill. Remove the four small screws that hold the dryer grill in place. The grill has sensors attached to it so be careful and don't pull the grill away damaging the sensors. Simply, swing the grill to the side and let it hang. Note, how the dryer heating element sits in the processor and how the wires are routed through to the other side so you can easily replace the element after cleaning.

Remove the dryer heating element and take compressed air and blow away any dust, lint or dirt found in the element. After inspecting the element and seeing it is clean replace the dryer heating element back into the processor.
